Office Products Division  
Customer Engineering

**VIDEO SUPPLEMENT**

**8/9xx**

**Print Quality**

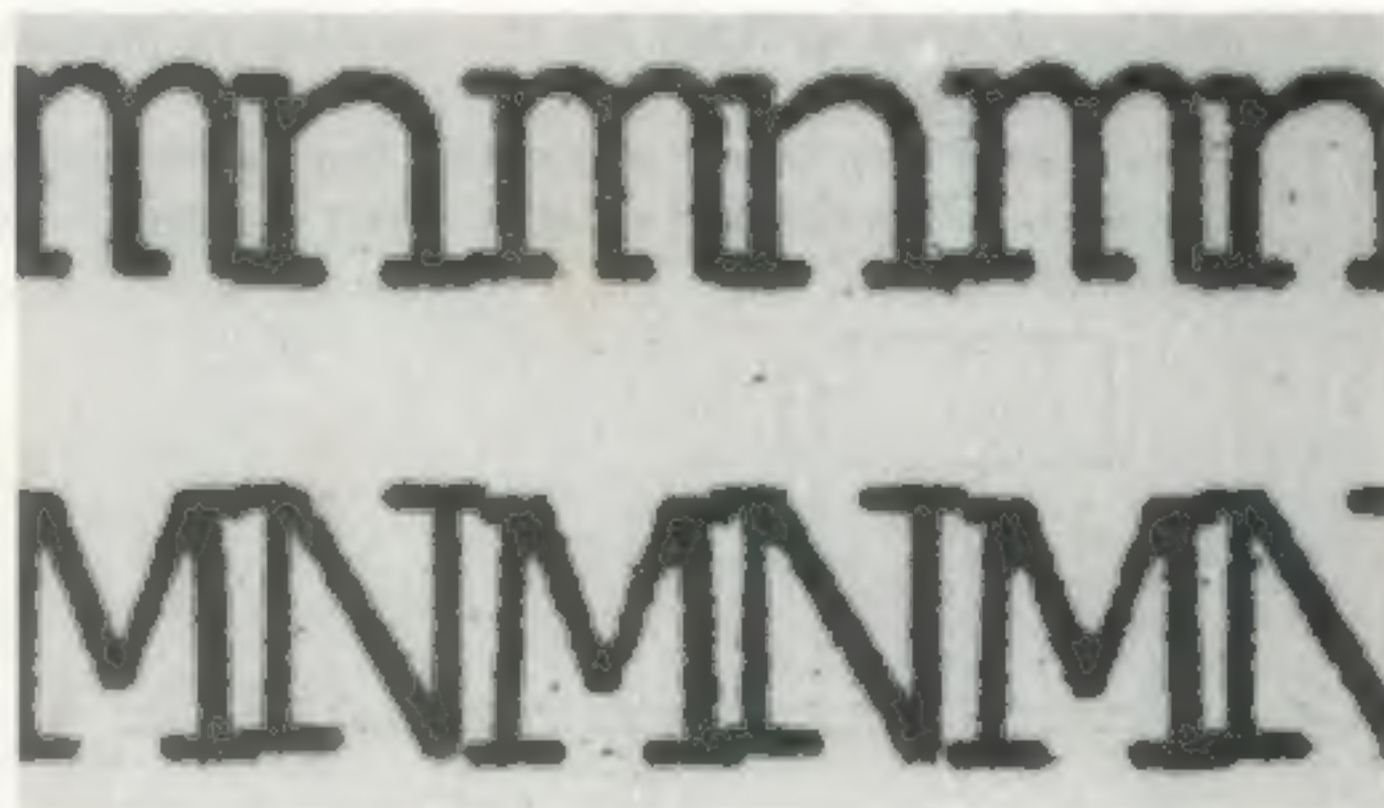
## VERTICAL MISALIGNMENT

Vertical misalignment problems can be caused by:

- Dirt on the upper ball socket flange
- Faulty typehead
- Play between typehead and tilt ring (socket worn)
- Play between upper ball socket and tilt ring
- Incorrect tilt detent adjustment
- Detent cam follower adjustment (see CEM 292)
- Tilt ring nose worn (see later section of this publication)

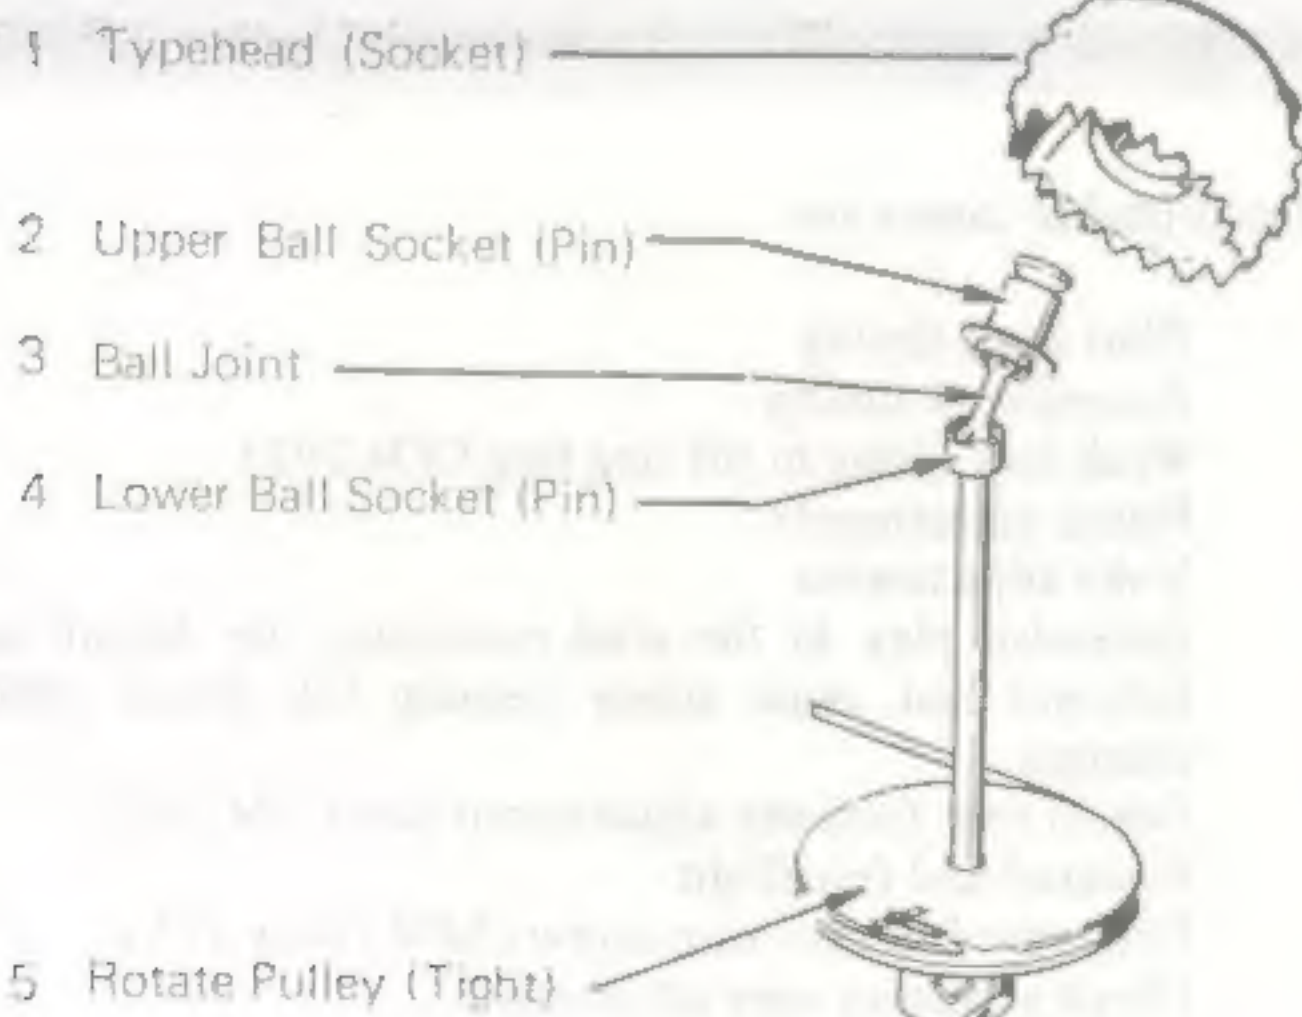
This is the rotational play in the typehead when the machine is at rest and the rotate pulley is tight on its shaft. The play is measured at the outside of the typehead skirt. When checking, use as little force as possible to turn the typehead making sure that **no movement of the rotate pulley occurs**. Headplay tolerance is controlled by the following parts.

**Headplay cannot be adjusted it is caused by parts tolerances.**

Headplay is necessary and is allowed between its tolerances. If headplay is too small, the rotate adjustments become very critical and after wear in the system, the drift will create wrong positions of the typehead teeth over the rotate detent.

If experiencing incorrect headplay check parts in the order mentioned above.

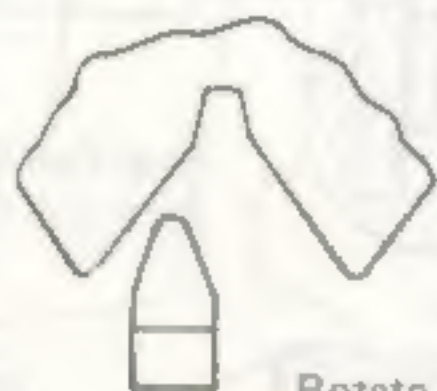
Rotate detent should enter the notch on the right hand side of the notch for every rotate position. This is necessary so that under power the typehead moves the rotate detent towards the tilt ring and not against it's guide. The slight difference in entry position between different rotate positions is allowed and is called **BANDWIDTH**.

Rotate Detent Enter The Notch On The Right Hand Side Of Typehead

(Rear View)

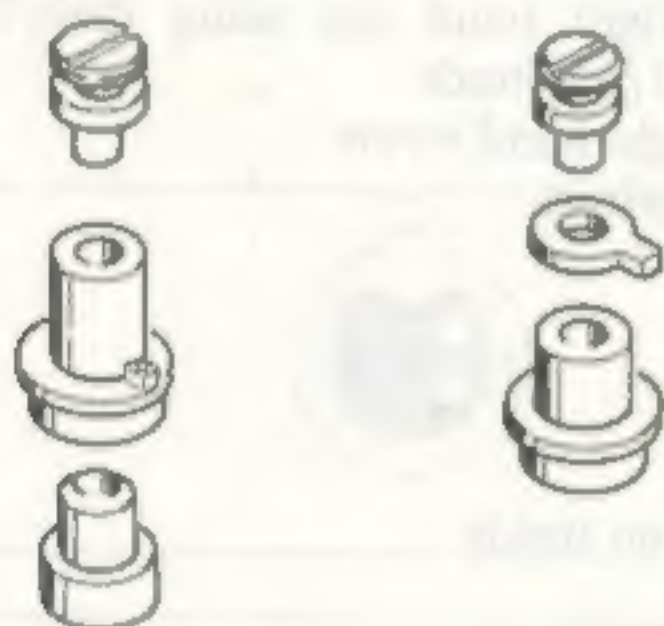
## RETAINER SCREWS

Don't overtighten, to cure the screw coming loose, only finger tips should be used (see CEM 292).

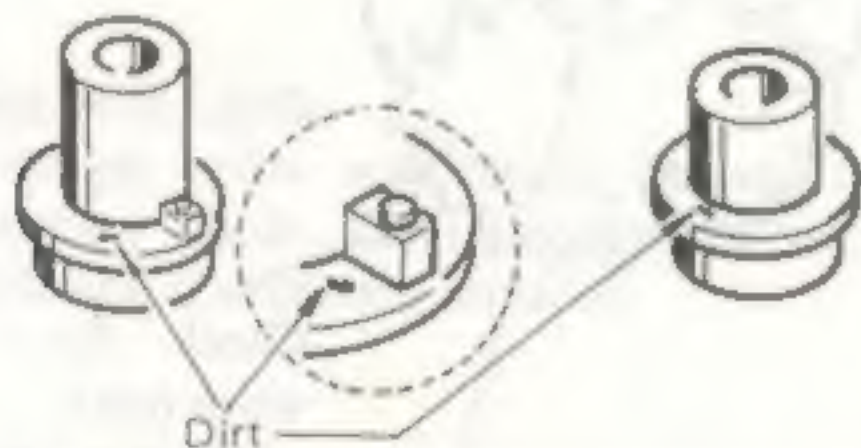
Print Sample With Dirt (Vertical Misalignment)

## UPPER BALL SOCKET FLANGE

This area must be clean and lubricated. Check this area for dirt or chrome from the typehead. If chrome is found check the typehead and replace if necessary.

If chrome is found check the typehead and replace if necessary.

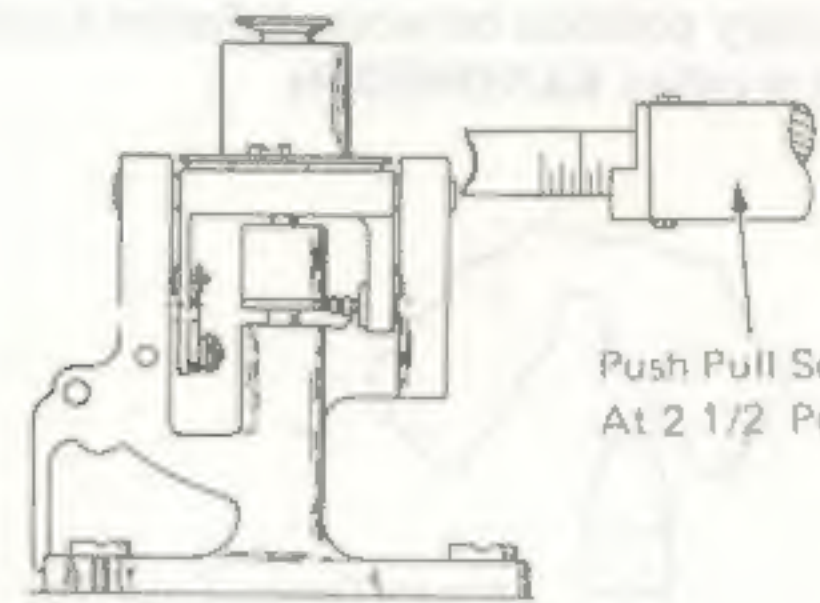
Push Pull Scale  
At 2 1/2 Pounds

To ensure good print quality a certain preload on the tilt ring is necessary

- Position carrier at left hand margin
- Remove rotate detent spring
- Remove tilt pulley spring
- Loosen the pivot pins locking screws
- Turn pins 1/4 turn in their holes
- Centre tilt ring between yoke legs
- Tighten left hand screw only
- Push in right hand pin using Push/Pull Scale until reading 2 1/2 pounds
- Tighten right hand screw
- Replace springs
